**ASBESTOS REGISTER  
NTB00261  
JABIRU GOVERNMENT CENTRE  
JABIRU  
NORTHERN TERRITORY**

**AEC Environmental Pty Ltd  
Date: March 2013  
Register No: NT0536**

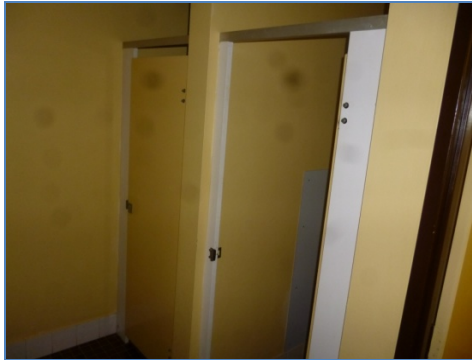
Location	Type of Material	Condition	
1. Cubicle partition in Female toilets (8m <sup>2</sup> )	Fibre cement sheet material containing white (Chrysotile) asbestos (sample no.1)	Stable

<b>Recommendation and Action</b>			
Warning signs: 2 small Refer Section 7.0: Management Procedures.

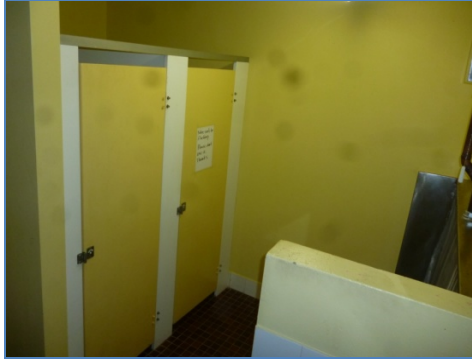
Location	Type of Material	Condition	
2. Cubicle partition in Male toilets (8m <sup>2</sup> )	Fibre cement sheet material containing white (Chrysotile) asbestos (per sample no.1)	Stable

<b>Recommendation and Action</b>			
Warning signs: 2 small Refer Section 7.0: Management Procedures.
