ASBESTOS REGISTER

NO. NT0687-G

Department of Infrastructure

Lot 8, Kalkarindji

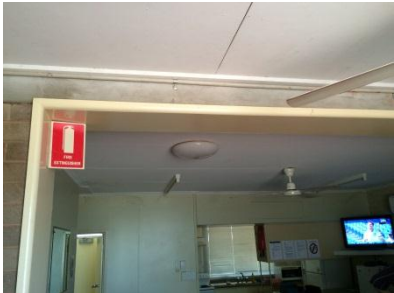
| INTERNAL | | | |
|--|--|---|---|
| 1. Ceiling linings throughout (65m ²) | Fibre cement sheet material containing white (Chrysotile) asbestos (sample no. 2014-3) | | |
| Non friable | Stable | Install 7 small warning signs | Low |

| INTERNAL | | | |
|--|--|---|---|
| Refer to Section 7.0: Policies & Management Procedures | | | |

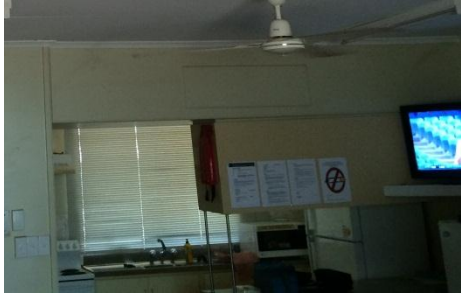
| INTERNAL | | | |
|--|--|---|---|
| 2. Bulkhead for redundant air-con duct, south side of house, including infill panels (12m ²) | Fibre cement sheet material containing white (Chrysotile) asbestos (sample no. 2014-4) | | |
| Non friable | Stable | Install 3 small warning signs | Low |

| INTERNAL | | | |
|--|--|---|---|
| Refer to Section 7.0: Policies & Management Procedures | | | |

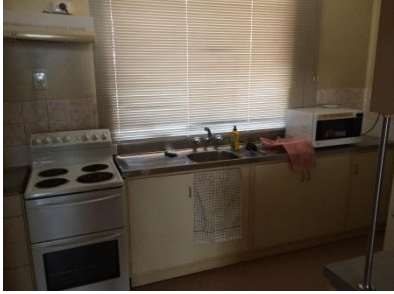
| INTERNAL (cont'd) | | | |
|--|--|---|---|
| 3. Kitchen sink, sound deadener | Black bituminous lump containing white (Chrysotile) asbestos (sample no. 2014-5) | | |
| Non friable | Stable | Install 1 small warning sign | Low |

| INTERNAL (cont'd) | | | |
|--|--|---|---|
| Refer to Section 7.0: Policies & Management Procedures | | | |
