**ASBESTOS REGISTER
NTB00340
DOI COMPLEX
TENNANT CREEK NT**

**Department of Infrastructure
PO Box 61, Palmerston NT 0831**

**AEC Environmental Pty Ltd
Date: May 2013
Register No: NT0545a**

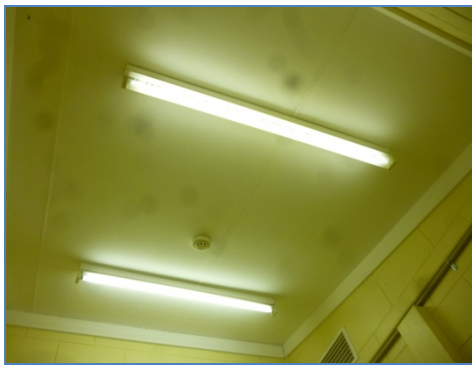
Location	Type of Material	Condition	
1. Ceiling lining – B9 (5m ²)	Fibre cement sheet material containing white (Chrysotile) asbestos (sample no.1)	Stable

Recommendation and Action			
Warning signs: 1 small sign Refer Section 7.0: Management Procedures.

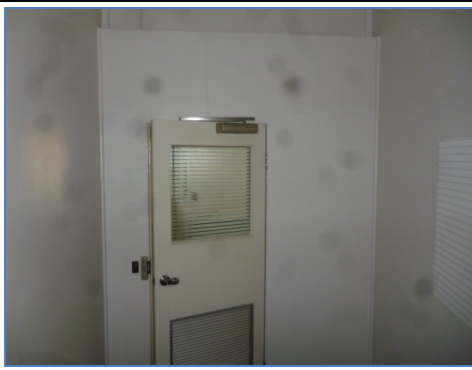
Location	Type of Material	Condition	
2. Wall lining in A3 Interview room – Northern elevation (5m ²)	Fibre cement sheet material containing white (Chrysotile) asbestos (sample no.2)	Stable

Recommendation and Action			
Warning signs: 1 small sign Refer Section 7.0: Management Procedures.

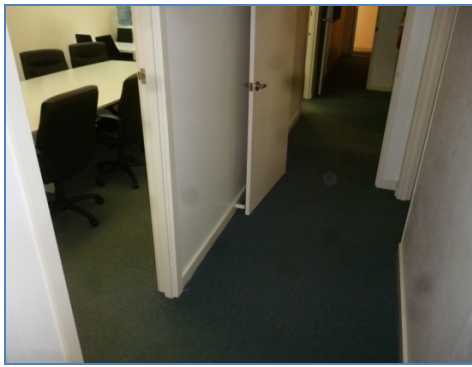
Location	Type of Material	Condition	
3. Floor covering under existing carpet throughout Northern elevation areas starting in B2. Also below first layer of vinyl tiles in A5 (100m ²)	Vinyl floor tiles containing white (Chrysotile) asbestos (sample no.4)	Stable

Recommendation and Action			
Warning signs: 10 small signs Refer Section 7.0: Management Procedures.

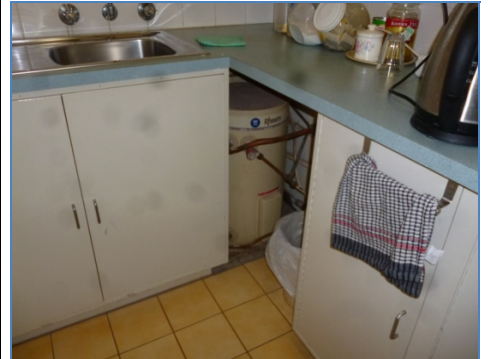
FRONT ADMIN – 01-00A (cont'd)		
Internal		
Location	Type of Material	Condition
4. Insulation to HWS under bench in A7 Kitchen (extent unknown)	Not accessed or sampled. Based on past experience in similar areas, asbestos in some form may exist. It is recommended that if work is contemplated in this area, due care & diligence should be exercised	Stable
Recommendation and Action		
Warning signs: 1 small sign Refer Section 7.0: Management Procedures.

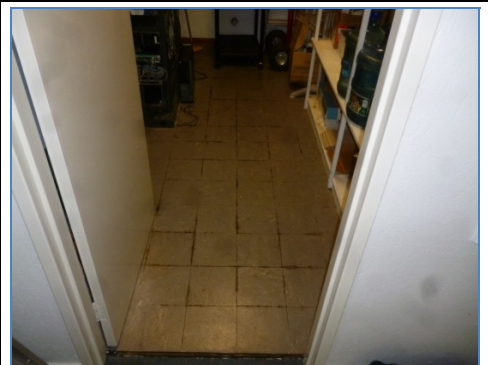
Location	Type of Material	Condition
5. Floor covering in A8 (7m ²)	Vinyl floor tiles containing white (Chrysotile) asbestos (sample no.5)	Stable
Recommendation and Action		
Warning signs: 1 small sign Refer Section 7.0: Management Procedures.

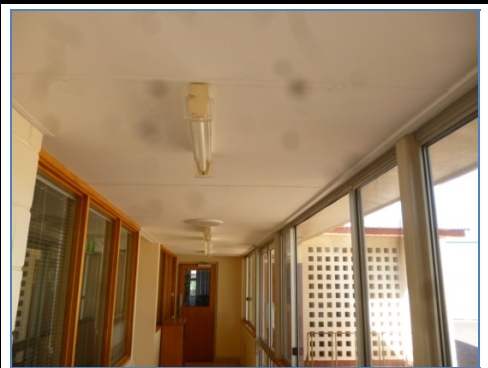
Location	Type of Material	Condition
6. Ceiling lining in B3 passage (11m ²)	Fibre cement sheet material containing white (Chrysotile) asbestos (sample no.6)	Stable
Recommendation and Action		
Warning signs: 2 small sign Refer Section 7.0: Management Procedures.

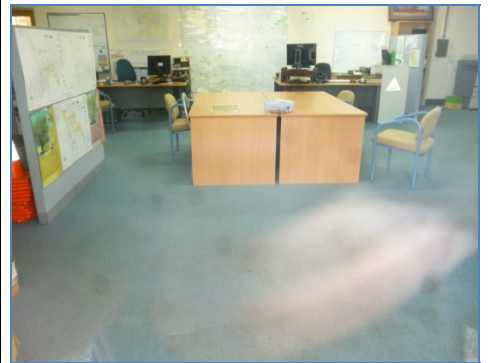
FRONT ADMIN – 01-00A (cont'd)		
Internal		
Location	Type of Material	Condition
7. Floor covering under existing carpet throughout office area starting at D5 (120m ²)	Vinyl floor tiles containing white (Chrysotile) asbestos (sample no.7)	Stable
Recommendation and Action		
Warning signs: 7 small sign Refer Section 7.0: Management Procedures.

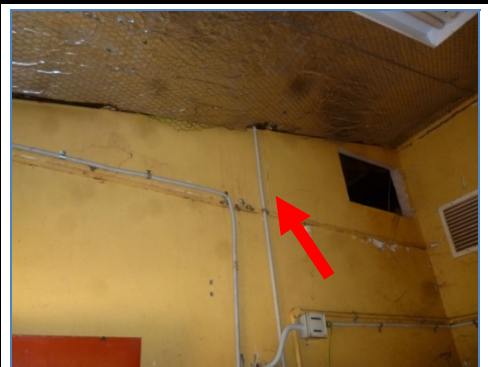
Location	Type of Material	Condition
8. High infill panel to Eastern elevation wall in C8 Plant room (2m ²)	Fibre cement sheet material containing white (Chrysotile) & grey/brown (Amosite) asbestos (sample no.8)	Stable
Recommendation and Action		
Warning signs: 1 small sign Refer Section 7.0: Management Procedures.

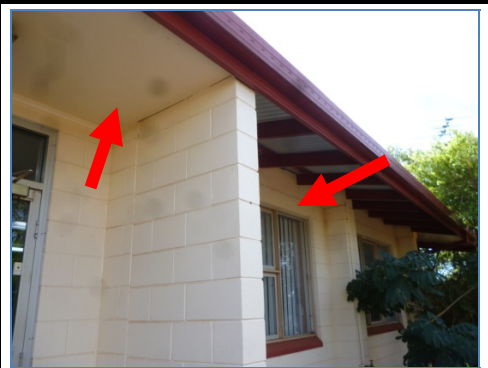
FRONT ADMIN – 01-00A		
External		
Location	Type of Material	Condition
9. High infill panels to Southern elevation wall (inc. soffit to bldg entry) (10m ²)	Fibre cement sheet material containing white (Chrysotile) asbestos (sample no.11)	Stable
Recommendation and Action		
Warning signs: 3 small sign Refer Section 7.0: Management Procedures.

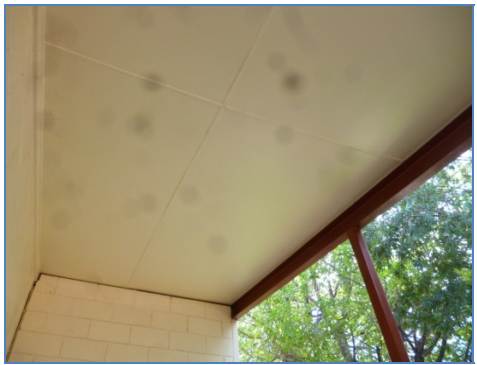
10. Soffit cladding - SE corner (10m ²)	Fibre cement sheet material containing white (Chrysotile) asbestos (sample no.13)	Stable	
Recommendation and Action			
Warning signs: 1 small sign Refer Section 7.0: Management Procedures.

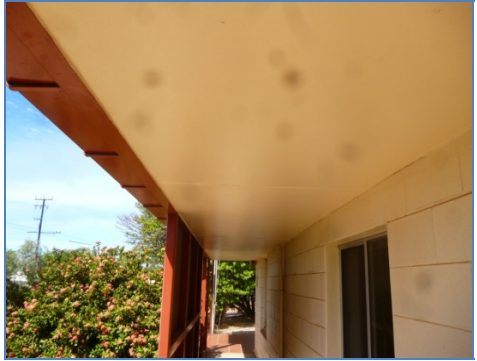
11. Eave cladding – NW elevation walkway (10m ²)	Fibre cement sheet material containing white (Chrysotile) asbestos (sample no.16)	Stable	
Recommendation and Action			
Warning signs: 2 small sign Refer Section 7.0: Management Procedures

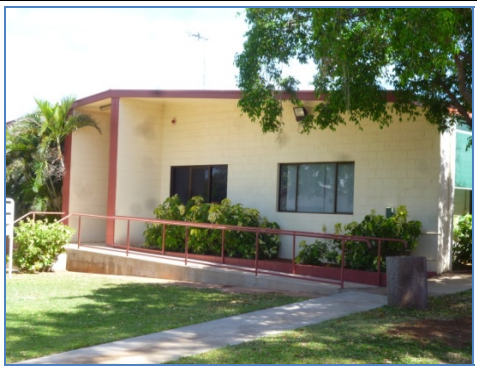
12. Paint coating on block work walls (extent unknown)	Textured paint containing white (Chrysotile) asbestos (sample no.19)	Stable	
Recommendation and Action			
Warning sign: 1 General Awareness sign Refer Section 6.0: Management Procedures.

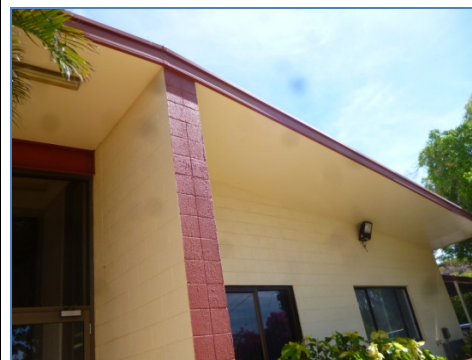
REAR ADMIN BLOCK – 01-00B (cont'd)		
External		
Location	Type of Material	Condition
13. Soffit cladding – Eastern & Western elevation (60m ²)	Not accessed or sampled. Based on past experience in similar areas, asbestos in some form may exist. It is recommended that if work is contemplated in this area, due care & diligence should be exercised	Stable
Recommendation and Action		
Warning signs: 2 small sign Refer Section 7.0: Management Procedures

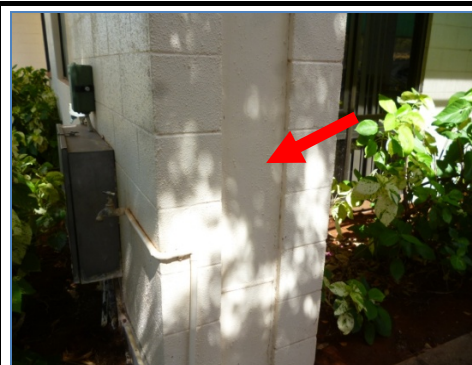
Location	Type of Material	Condition
14. Infill panels to columns, all elevations (10m ²)	Fibre cement sheet material containing white (Chrysotile) asbestos (sample no.20)	Stable
Recommendation and Action		
Warning signs: 1 small sign on each column Refer Section 7.0: Management Procedures

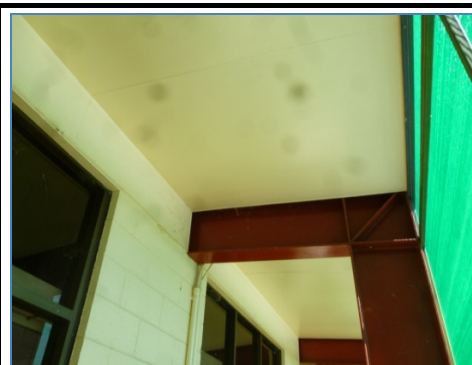
Location	Type of Material	Condition
15. High infill panels & soffit cladding – Northern & Southern elevations (80m ²)	Fibre cement sheet material containing white (Chrysotile) asbestos (sample no.21)	Stable
Recommendation and Action		
Warning signs: 4 small sign Refer Section 7.0: Management Procedures

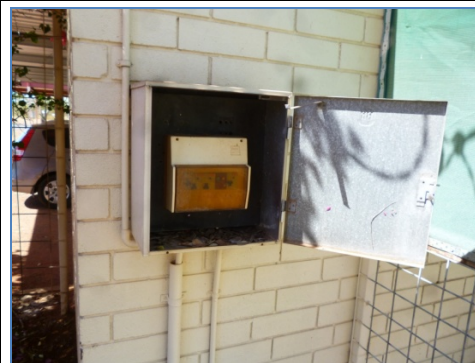
01-00C - External		
Location	Type of Material	Condition
16. Backing board in Circuit breaker switch box – Western elevation of A1 (<1m ²)	Zelemite material containing white (Chrysotile) asbestos (sample no.22)	Stable
Recommendation and Action		
Warning signs: 4 small sign Refer Section 7.0: Management Procedures.

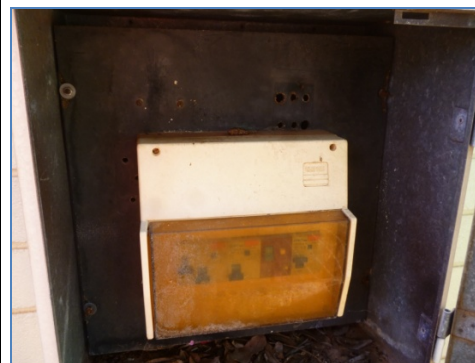
Location	Type of Material	Condition
17. Dust in A1 Switch box surfaces (extent unknown)	Potential Asbestos Contaminated Dust Area accessed and not sampled. Based on findings in similar areas it is possible that the dust contains asbestos (see note)	Friable
Recommendation and Action		
<p>Remove</p> <p>Refer Section 7.0: Management Procedures</p> <p>Note: Asbestos Contaminated Dust (ACD) represents a significant risk of airborne asbestos exposure. The likelihood of ACD becoming airborne is considerable with minimal disturbance.</p> <p>An investigation to determine if the dust does contain asbestos and the extent of any asbestos contamination is recommended.</p> <p>If detected, an asbestos management plan is required to document the specific procedures to control the significant risk that ACD and other asbestos containing products pose.</p>

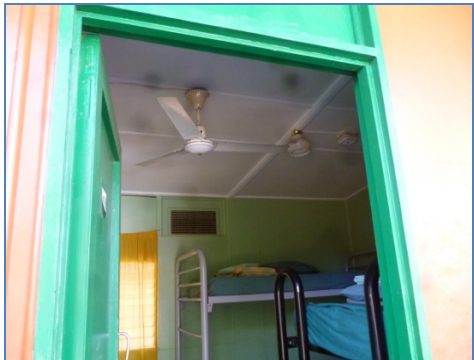
HOSTEL - 01-00D		
Internal		
Location	Type of Material	Condition
18. Ceiling lining in Reception area & Eastern Wing rooms (80m ²)	Fibre cement sheet material containing white (Chrysotile) & grey/brown (Amosite) asbestos (sample no.23)	Stable
Recommendation and Action		
Warning signs: 5 small sign Refer Section 7.0: Management Procedures.

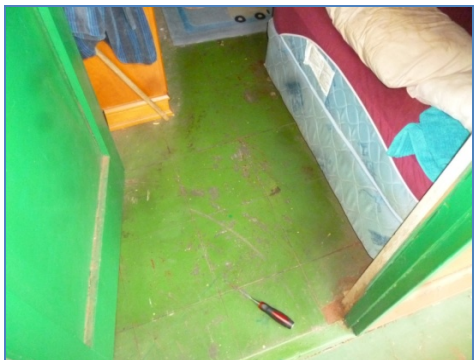
HOSTEL - 01-00D (cont'd)		
Internal		
Location	Type of Material	Condition
19. Floor covering in Reception & room 7 (25m ²)	Vinyl floor tiles containing white (Chrysotile) asbestos (sample no.24)	Stable
Recommendation and Action		
Warning signs: 2 small sign Refer Section 7.0: Management Procedures.

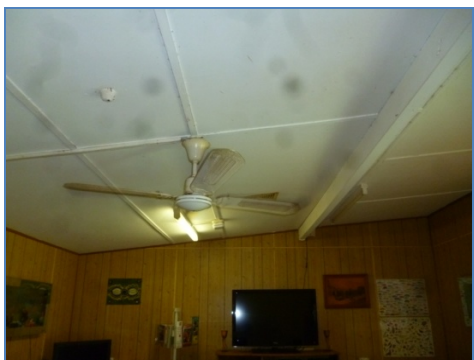
Location	Type of Material	Condition
20. Ceiling lining in Kitchen (20m ²)	Fibre cement sheet material containing white (Chrysotile) & grey/brown (Amosite) asbestos (sample no. per 23)	Stable
Recommendation and Action		
Warning signs: 8 small sign Refer Section 7.0: Management Procedures.

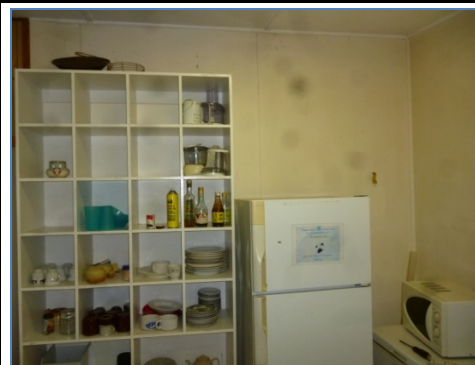
HOSTEL - 01-00D (cont'd)		
Internal		
Location	Type of Material	Condition
21. Wall lining in A6 Kitchen – SW elevation (5m ²)	Fibre cement sheet material containing white (Chrysotile) asbestos (sample no.25)	Stable
Recommendation and Action		
Warning sign: 1 small sign Refer Section 7.0: Management Procedures.

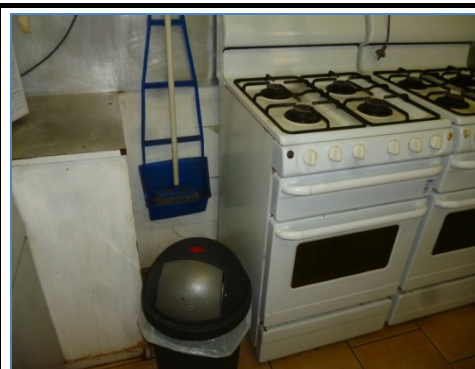
Location	Type of Material	Condition
22. Wall lining behind stoves in A6 Kitchen – NW elevations (2m ²)	Vinyl tiles containing white (Chrysotile) asbestos (sample no.26)	Stable
Recommendation and Action		
Warning sign: 1 small sign Refer Section 7.0: Management Procedures.

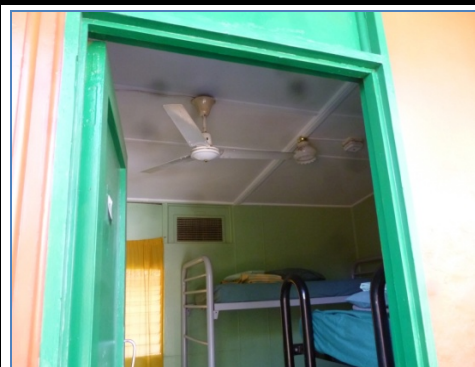
Location	Type of Material	Condition
23. Ceiling lining throughout West Wing (80m ²)	Fibre cement sheet material containing white (Chrysotile) asbestos (sample no.27)	Stable
Recommendation and Action		
Warning signs: 6 small signs Refer Section 7.0: Management Procedures.

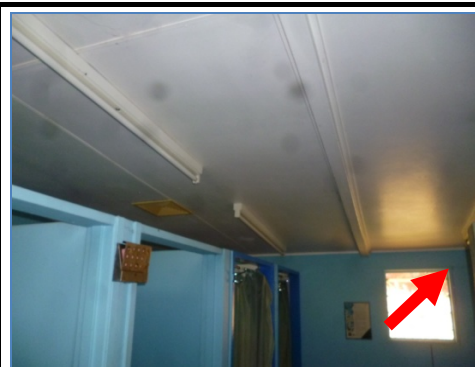
Location	Type of Material	Condition
24. High infill panels in A7 toilets – Northern, Eastern & Southern elevation walls (4m ²)	Fibre cement sheet material containing white (Chrysotile) asbestos (sample no.28)	Stable
Recommendation and Action		
Warning signs: 3 small signs Refer Section 7.0: Management Procedures.

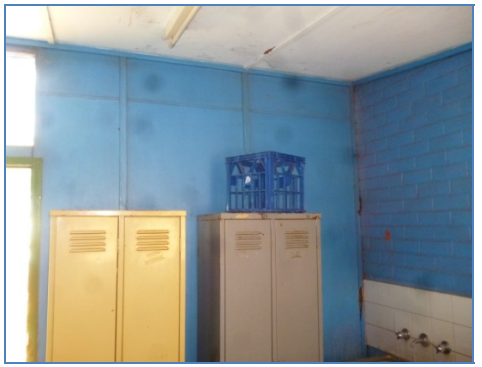
26. Wall lining in B5 Laundry – Northern & Southern elevation (10m ²)	Fibre cement sheet material containing white (Chrysotile) asbestos (sample no.30)	Stable	
Recommendation and Action			
Warning signs: 2 small signs Refer Section 7.0: Management Procedures.

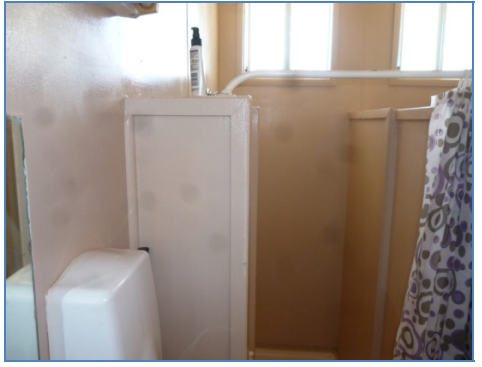
27. Wall & partition lining throughout Female toilet/shower block (30m ²)	Fibre cement sheet material containing white (Chrysotile) asbestos (sample no.31)	Stable	
Recommendation and Action			
Warning signs: 2 small signs Refer Section 7.0: Management Procedures.

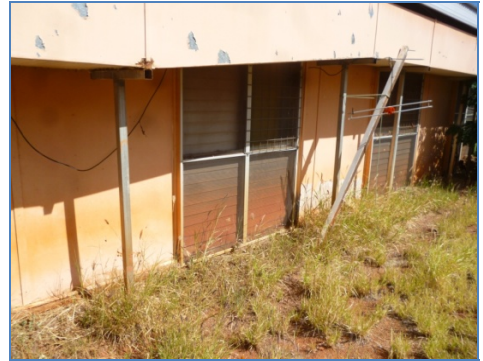
HOSTEL - 01-00D		
External		
Location	Type of Material	Condition
28. Wall cladding panels throughout (150m ²)	Fibre cement sheet material containing white (Chrysotile) & grey/brown (Amosite) asbestos (sample no.32)	Unstable in areas. Some with minor damage
Recommendation and Action		
Encapsulate/Remove Warning signs: 15 small signs Refer Section 6.0: Management Procedures.

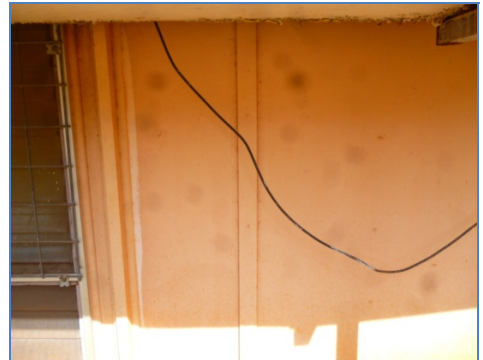
Location	Type of Material	Condition
29. Cover strips to panel joins throughout (extent unknown)	Moulded cement sheet material containing white (Chrysotile) & grey/brown (Amosite) asbestos (sample no.33)	Stable
Recommendation and Action		
Warning sign: 1 General Awareness sign Refer Section 7.0: Management Procedures

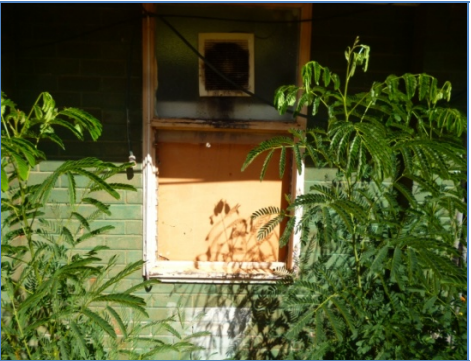
HOSTEL - 01-00D (cont'd)			
External			
Location	Type of Material	Condition	
30. Infill panel in A6 Kitchen wall – Northern elevation (<1m ²)	Fibre cement sheet material containing white (Chrysotile) & grey/brown (Amosite) asbestos (sample no.34)	Stable

Recommendation and Action			
Warning sign: 1 small sign Refer Section 6.0: Management Procedures.

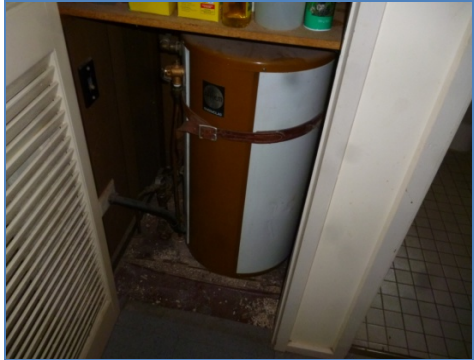
FLAT 1 – VOQ - 01-00E-01			
Internal			
Location	Type of Material	Condition	
32. Insulation in Rheem HWS in cupboard adjacent to toilets (<1m ²)	Not accessed or sample. Based on past experience in similar areas, asbestos in some form may exist. It is recommended that if work is contemplated in this area, due care & diligence should be exercised.	Friable when Exposed

Recommendation and Action			
Warning sign: 1 small sign Refer Section 6.0: Management Procedures.

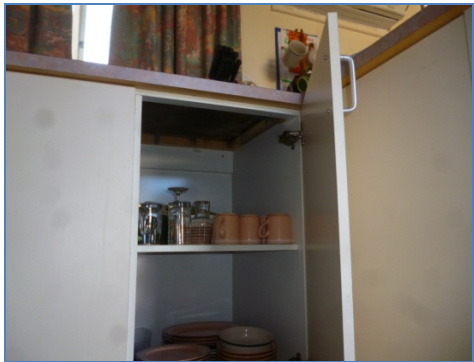
Location	Type of Material	Condition	
33. Sound proofing under sink (<1m ²)	Bituminous material containing white (Chrysotile) asbestos (sample no.39)	Stable

Recommendation and Action			
Warning sign: 1 small sign Refer Section 6.0: Management Procedures.

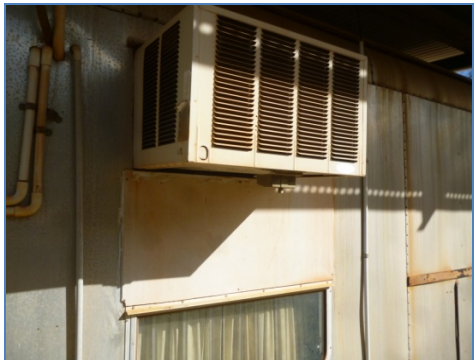
FLAT 2 - VOQ - 01-00E-02			
- External			
Location	Type of Material	Condition	
34. Infill panels around AC units at rear unit	Fibre cement sheet material containing white (Chrysotile) asbestos (sample no.41)	Unstable

Recommendation and Action			
Encapsulate/Remove Warning signs: 2 small signs Refer Section 6.0: Management Procedures.

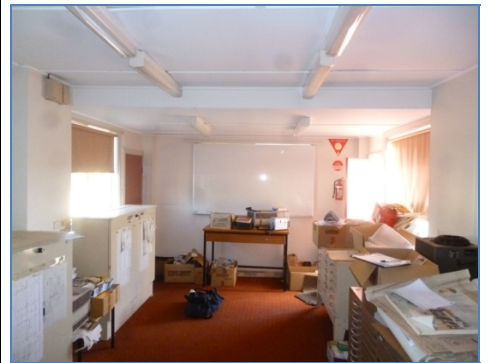
ARCHIVES – 02-00B		
Internal		
Location	Type of Material	Condition
35. Wall lining in A1 Computer room – Southern elevation (15m ²)	Fibre cement sheet material containing white (Chrysotile) asbestos (sample no.42)	Stable
Recommendation and Action		
Warning signs: 3 small signs Refer Section 6.0: Management Procedures.

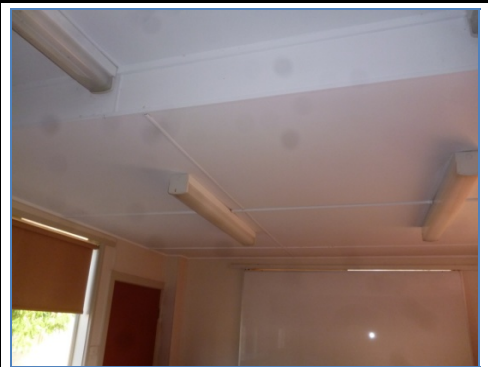
Location	Type of Material	Condition
36. Ceiling lining in A1 – Southern elevation (12m ²)	Fibre cement sheet material containing white (Chrysotile) asbestos (sample no.43)	Stable
Recommendation and Action		
Warning sign: 1 small sign Refer Section 6.0: Management Procedures.

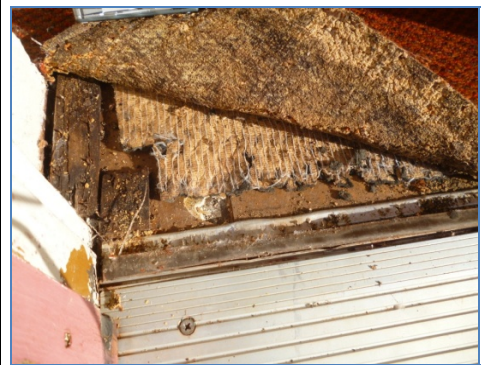
Location	Type of Material	Condition
37. Floor covering under existing carpet & existing vinyl tiles (30m ²)	Vinyl tiles containing white (Chrysotile) asbestos (sample no.45)	Stable
Recommendation and Action		
Warning signs: 2 small signs Refer Section 6.0: Management Procedures.

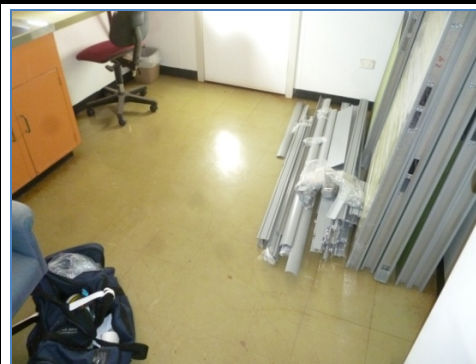
ARCHIVES – 02-00B (cont'd)		
Internal		
Location	Type of Material	Condition
38. Floor covering in A2 Kitchen (10m ²)	Vinyl tiles containing white (Chrysotile) asbestos (sample no.46)	Stable
Recommendation and Action		
Warning signs: 2 small signs Refer Section 6.0: Management Procedures.

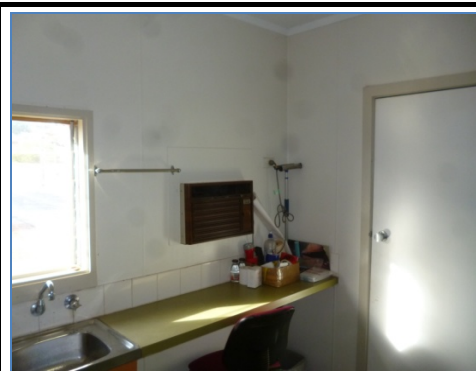
Location	Type of Material	Condition
39. Wall lining in A2 Kitchen (15m ²)	Fibre cement sheet material containing white (Chrysotile) asbestos (sample no.47)	Stable
Recommendation and Action		
Warning signs: 2 small signs Refer Section 6.0: Management Procedures.

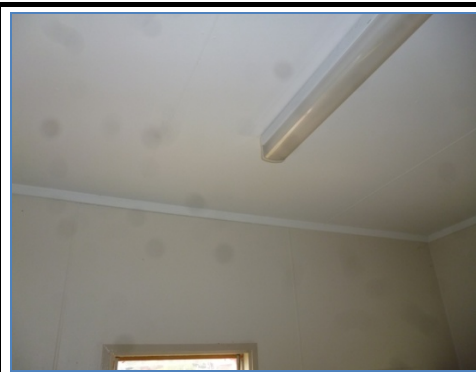
Location	Type of Material	Condition
40. Ceiling lining in A2 Kitchen (10m ²)	Fibre cement sheet material containing white (Chrysotile) asbestos (sample no.48)	Stable
Recommendation and Action		
Warning sign: 1 small sign Refer Section 6.0: Management Procedures.

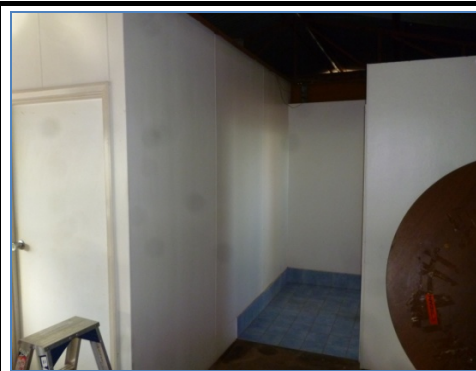
Location	Type of Material	Condition
41. Wall lining to A3 Eastern elevation (inc. toilet area) (20m ²)	Fibre cement sheet material containing white (Chrysotile) asbestos (sample no.49)	Stable
Recommendation and Action		
Warning signs: 4 small signs Refer Section 6.0: Management Procedures.

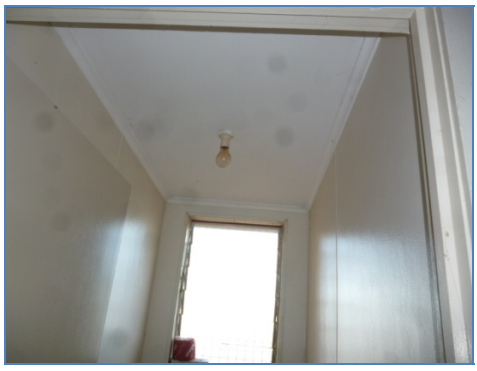
Location	Type of Material	Condition	
42. Wall lining in A4 toilets (8m ²)	Fibre cement sheet material containing white (Chrysotile) asbestos (sample no.50)	Stable

Recommendation and Action			
Warning sign: 1 small sign Refer Section 6.0: Management Procedures.

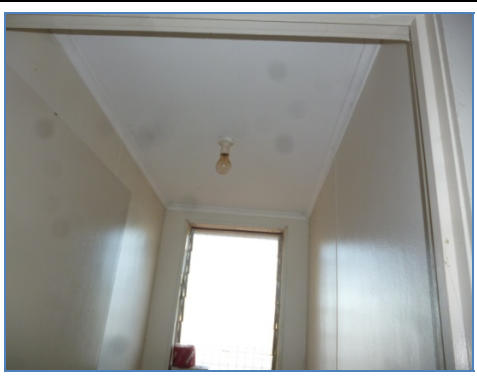
Location	Type of Material	Condition	
43. Ceiling lining in A4 toilets (4m ²)	Fibre cement sheet material containing white (Chrysotile) & grey/brown (Amosite) asbestos (sample no.51)	Stable

Recommendation and Action			
Warning sign: 1 small sign Refer Section 6.0: Management Procedures.

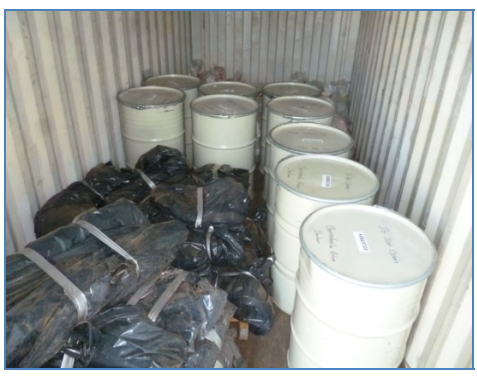
Location	Type of Material	Condition	
44. Shipping Container sitting on B2 carport slab. Contains Asbestos waste from the Booraloola Police Station (extent unknown)	Area accessed but not sampled. Based on findings in similar area, it is highly likely to contain asbestos	Stable

Recommendation and Action			
Appropriately signed Refer Section 7.0: Management Procedures

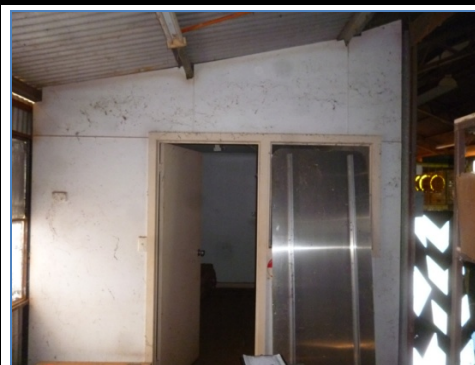
ROAD STORE – 02-00C		
Internal		
Location	Type of Material	Condition
45. Outer wall lining in A2 office (4m ²)	Fibre cement sheet material containing white (Chrysotile) asbestos (sample no.55)	Stable
Recommendation and Action		
Warning sign: 1 small sign Refer Section 6.0: Management Procedures.

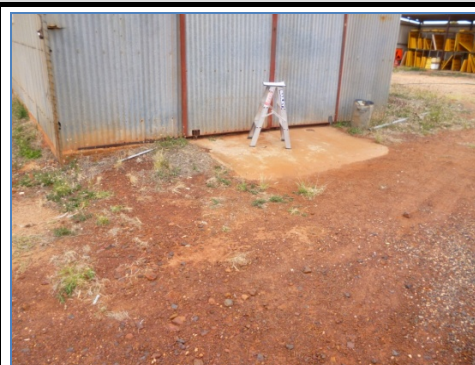
External		
Location	Type of Material	Condition
46. Debris on ground at northern elevation Entry doors (extent unknown)	Debris containing white (Chrysotile) asbestos (sample no.56)	Unstable
Recommendation and Action		
Remove Refer Section 6.0: Management Procedures.

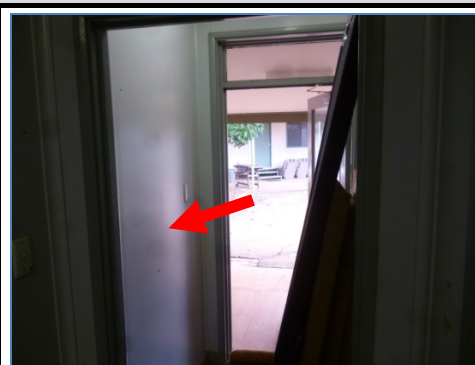
MATERIALS LAB – 04-00A		
Internal		
Location	Type of Material	Condition
47. Wall lining throughout A1 office (80m ²)	Fibre cement sheet material containing white (Chrysotile) asbestos (sample no.57)	Stable
Recommendation and Action		
Warning signs: 2 small signs Refer Section 7.0: Management Procedures

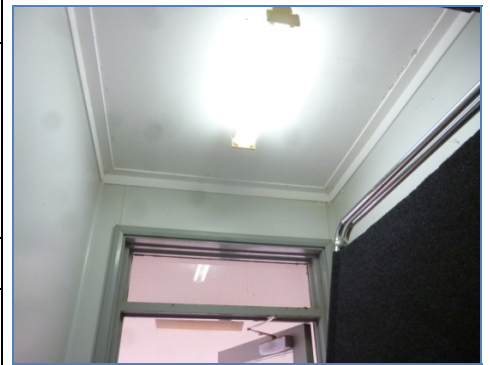
MATERIALS LAB – 04-00A (cont'd)		
Internal		
Location	Type of Material	Condition
48. Ceiling lining throughout A1 office (30m ²)	Fibre cement sheet material containing white (Chrysotile) asbestos (sample no.58)	Stable
Recommendation and Action		
Warning sign: 1 small sign Refer Section 6.0: Management Procedures.

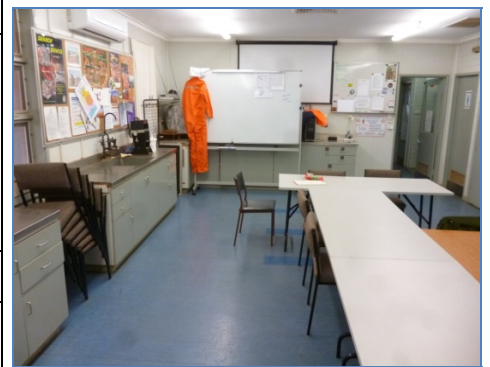
Location	Type of Material	Condition
49. Wall linings throughout accessed area A2, A5, A6, A7 (120m ²) No access to A4, A3, or A8. Locked.	Fibre cement sheet material containing white (Chrysotile) asbestos (per sample no.57)	Stable
Recommendation and Action		
Warning signs: 6 small signs Refer Section 7.0: Management Procedures

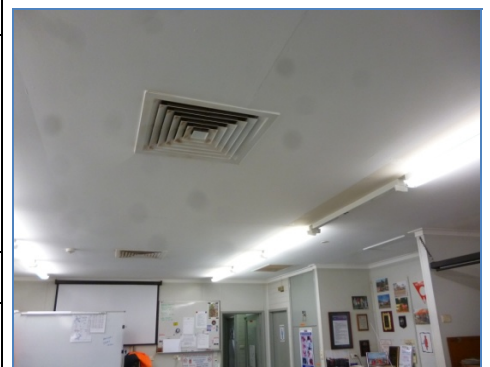
Location	Type of Material	Condition
50. Ceiling linings throughout accessed area- A2, A5, A6, A7(120m ²) No access to A4, A3, or A8. Locked.	Fibre cement sheet material containing white (Chrysotile) asbestos (per sample no.58)	Stable
Recommendation and Action		
Warning signs: 5 small signs Refer Section 7.0: Management Procedures

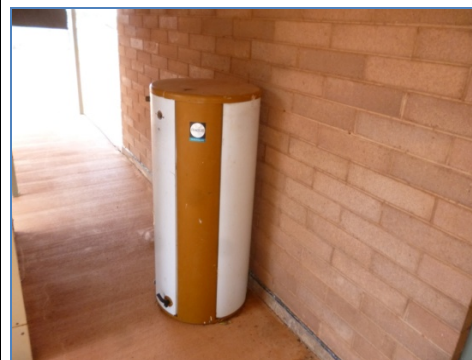
MATERIALS LAB – 04-00A		
External		
Location	Type of Material	Condition
51. Insulation in Rheem HWS dated 1980 on Eastern elevation verandah (extent unknown)	Not accessed or sample. Based on past experience in similar areas, asbestos in some form may exist. It is recommended that if work is contemplated in this area, due care & diligence should be exercised.	Friable when Exposed
Recommendation and Action		
Warning sign: 1 small sign Refer Section 6.0: Management Procedures.

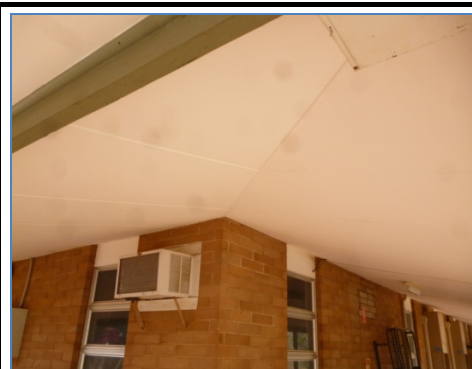
Location	Type of Material	Condition
52. Ceiling cladding to Veranda throughout (120m ²)	Fibre cement sheet material containing white (Chrysotile) asbestos (per sample no.60)	Stable
Recommendation and Action		
Warning signs: 6 small signs Refer Section 7.0: Management Procedures

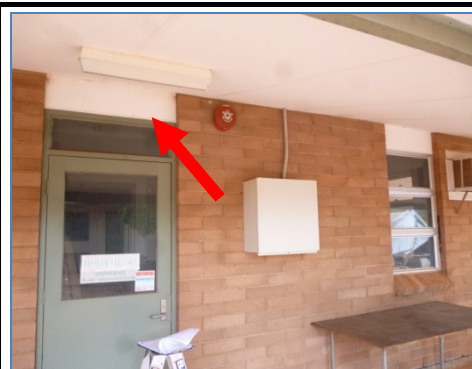
Location	Type of Material	Condition
53. Higher infill panels above windows & doors throughout (<1m ² each)	Fibre cement sheet material containing white (Chrysotile) asbestos (per sample no.61)	Stable
Recommendation and Action		
Warning sign: 1 small sign to each Refer Section 6.0: Management Procedures.

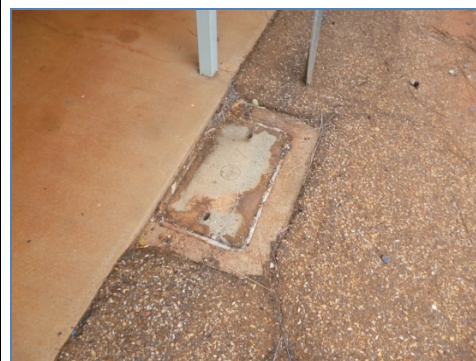
MATERIALS LAB – 04-00A (cont'd)		
External		
Location	Type of Material	Condition
54. Telstra pit box, adjacent to Eastern elevation verandah (1m ²)	Moulded cement material containing white (Chrysotile) asbestos (sample no.62)	Unstable Exposed edges
Recommendation and Action		
Encapsulate Warning sign: 1 General Awareness sign Refer Section 7.0: Management Procedures
