# ASBESTOS REGISTER

NO. NT0687-H

Lot 232 Lajamanu

January 2015

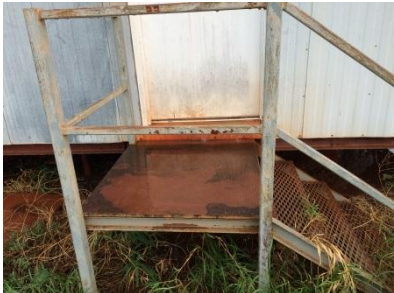
EXTERNAL			
Location	Type of Material		
1. Fire escape stair landing (1m <sup>2</sup> )	Fibre cement sheet material containing white (Chrysotile) asbestos (sample no. 2014-1)

Recommendation and Action			
Refer to Section 7.0: Policies & Management Procedures			
Situational Asbestos Risk Assessment:			
Friability	Condition	Signage	Risk Rating
Non friable	Stable	Install 1 small plastic warning sign	Low

LOCATION	SAMPLE I/D NO.	LABORATORY RESULTS
<b>EXTERNAL</b>		
Fire escape stair landing (1m <sup>2</sup> )	No.1	White (Chrysotile) asbestos
<b>INTERNAL</b>		
Panel on either side of toilet door; left wall of toilet, and toilet-side wall of second bedroom (16m <sup>2</sup> )	No.2	No asbestos
Bathroom walls (8m <sup>2</sup> )	No.3	White (Chrysotile) asbestos

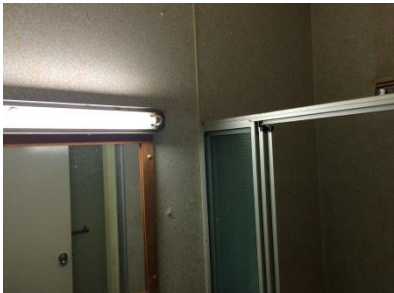
INTERNAL			
Location	Type of Material		
2. Bathroom walls (8m <sup>2</sup> )	Fibre cement sheet material containing white (Chrysotile) asbestos (sample no. 2014-3)

Recommendation and Action			
Refer to Section 7.0: Policies & Management Procedures			
Situational Asbestos Risk Assessment:			
Friability	Condition	Signage	Risk Rating
Non friable	Stable	Install 1 small warning sign	Low
