ASBESTOS MANAGEMENT PLAN

AMP NT0687-G

Department of Infrastructure

Lot 8, Kalkarindji

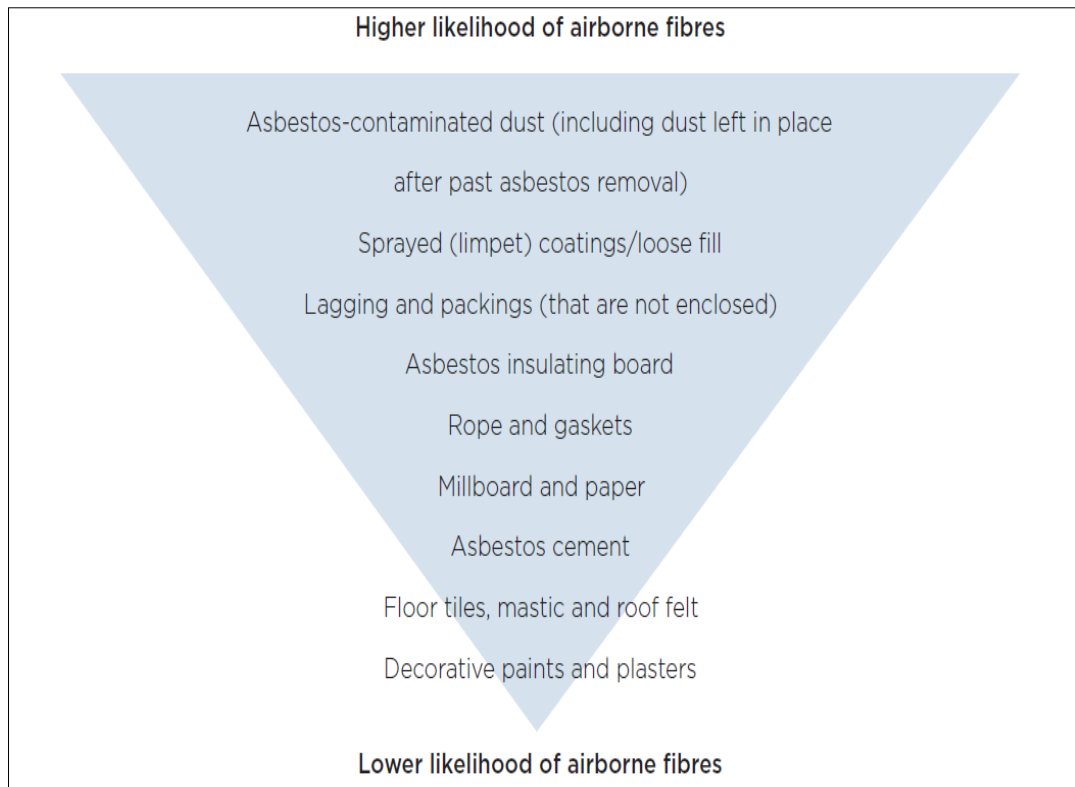
Figure 1: Extract from the SafeWork Australia Code of Practice: "How to Manage and Control Asbestos in the Workplace (December 2011"

The following list ranks different types of asbestos according to the likelihood that airborne asbestos can be released into the air if it has deteriorated or been disturbed. The potential risk to health is greater for items higher up the list if people are exposed to airborne asbestos, but any ACM can produce asbestos fibres if they are disturbed.
