Barneson Boulevard

Contamination Assessment Summary

Community Information Sheet

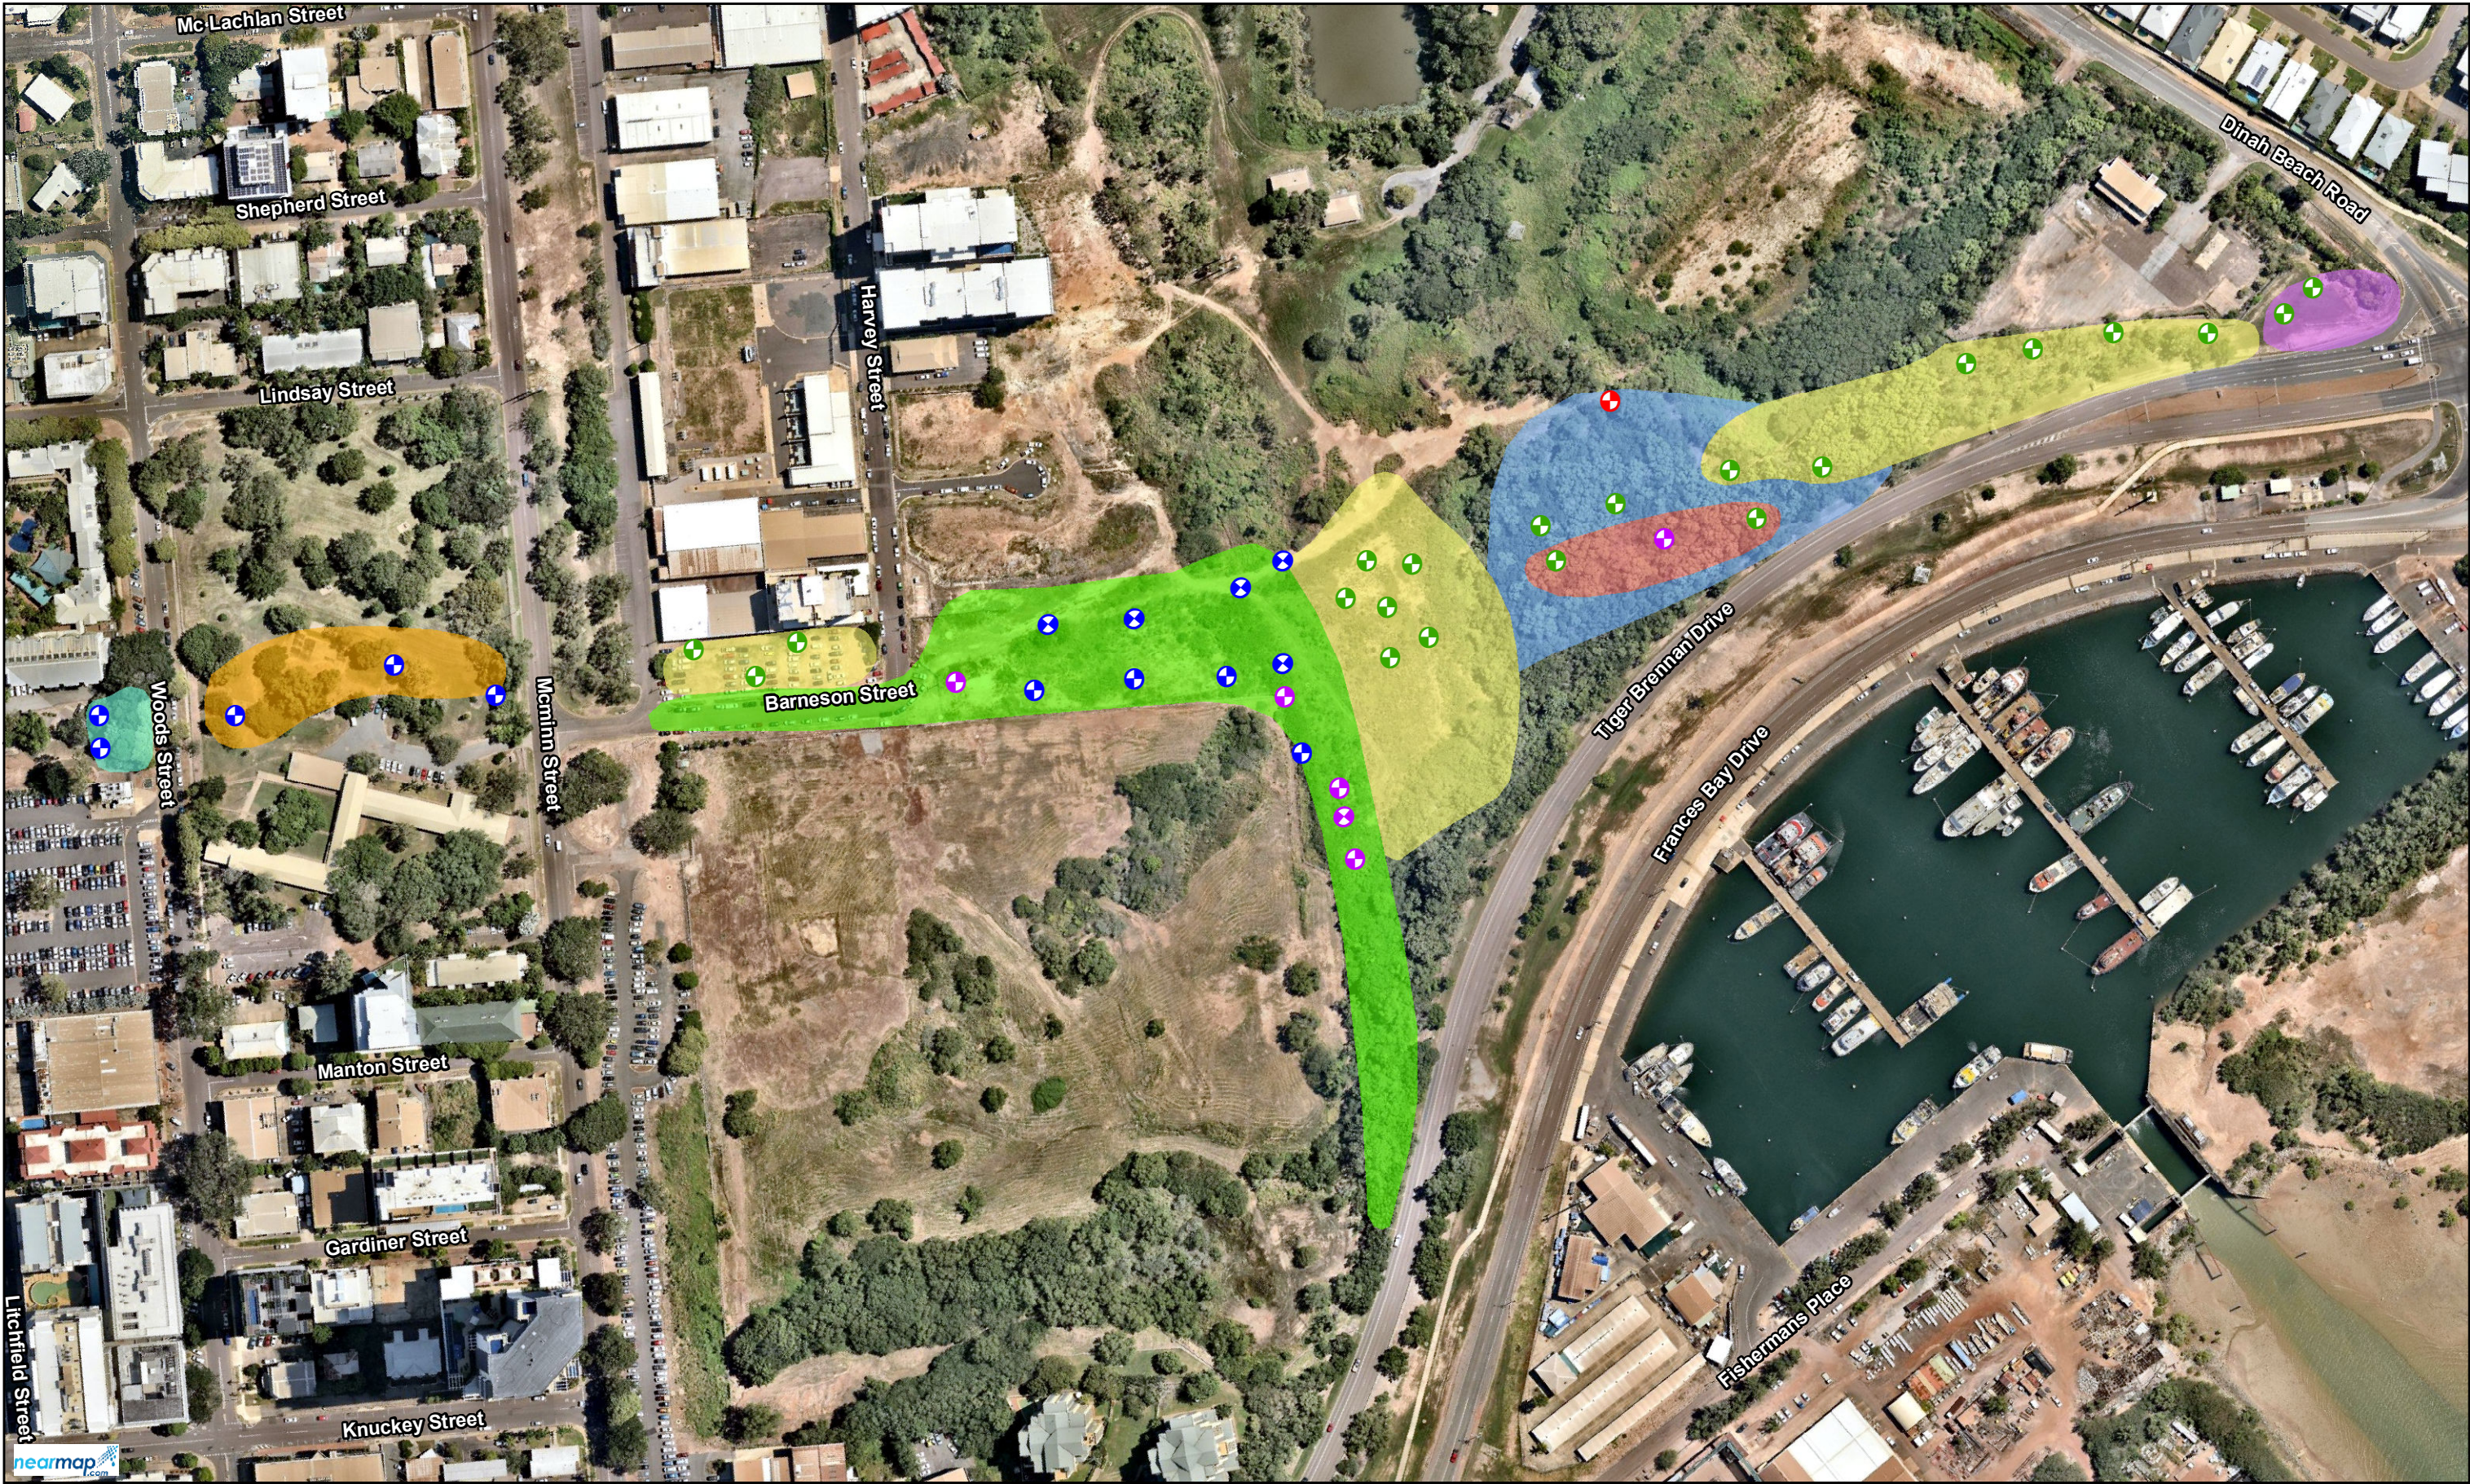
Seven areas requiring further environmental investigation, including soil, groundwater and surface water sampling, were identified (Figure 1).

The seven areas identified in the preliminary environmental assessment, have been investigated by GHD as part of this current study. These areas are shown in Figure 1 and include:

- Area 1: The electrical switching station on Woods Street;
- Area 2: A former primary school where buildings had previously been demolished;
- Area 3: Three areas of imported fill material;
- Area 4: The north western and north eastern boundary of the former Shell terminal;
- Area 5: A stormwater drainage channel near Tiger Brennan Drive;
- Area 6: A former quarantine nursery located at the corner of Tiger Brennan Drive and Dinah Beach Road; and
- Area 7: A mangrove area adjacent to Tiger Brennan Drive.
